Amazon Fire Tablet (5th Generation)

Repairability Assessment

Repairability assessment for the Amazon Fire Tablet, 5th Generation performed on January 5, 2017.

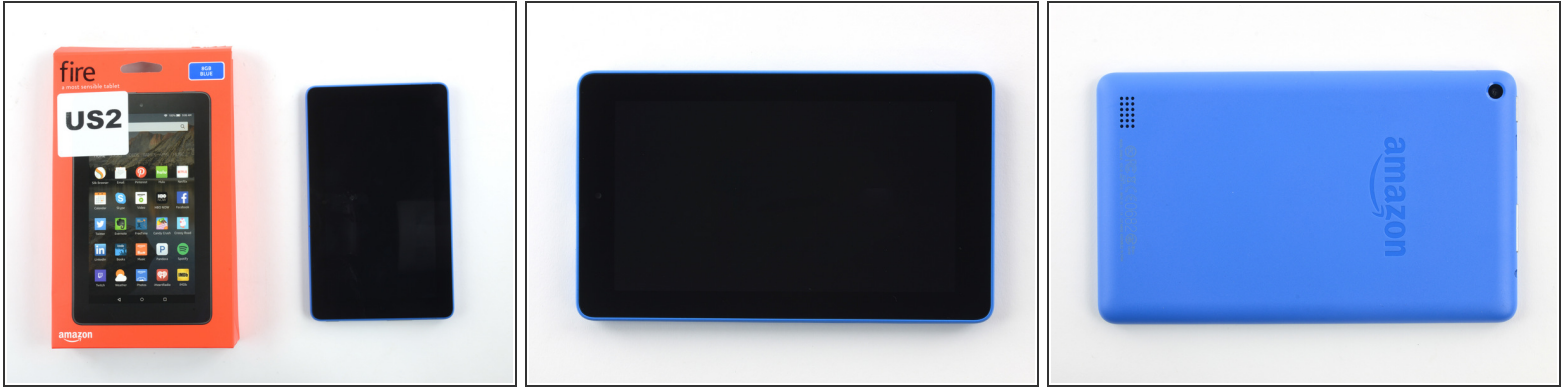
Step 1 — Amazon Fire Tablet (5th Generation) Repairability Assessment

- Front and back reference shots.

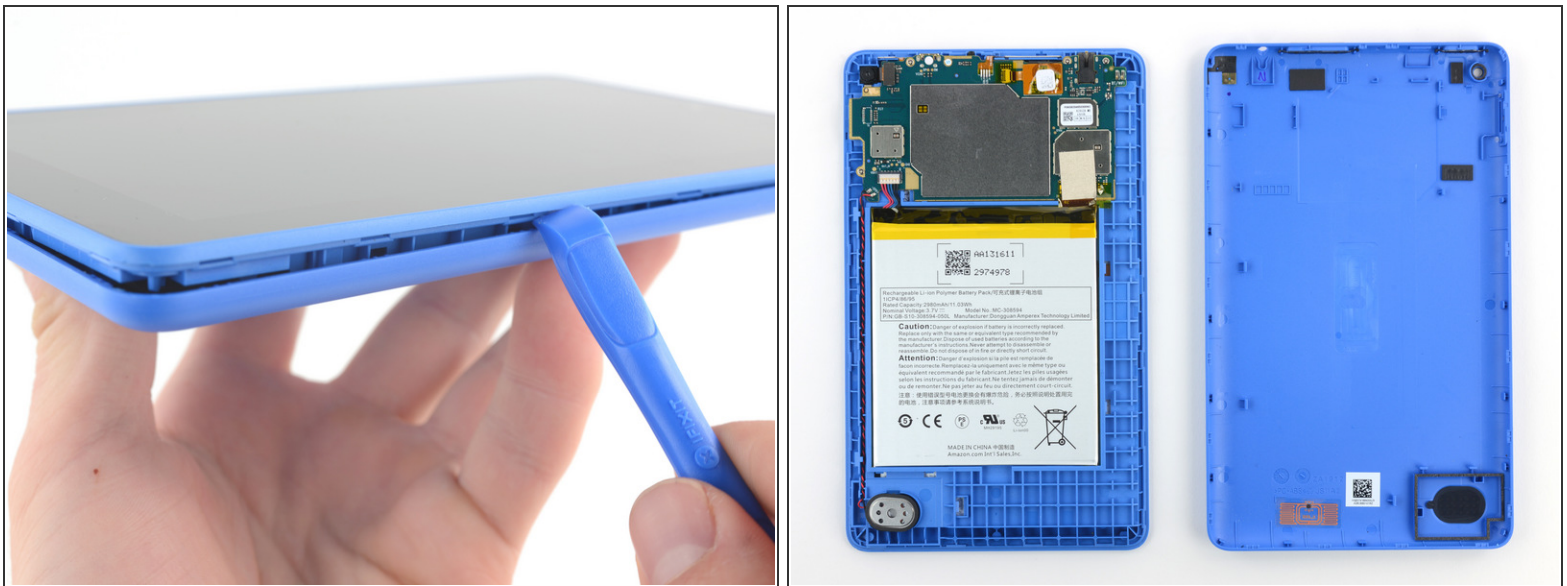
Step 2

- There are only clips holding the assembly together. No adhesive makes for much easier device access.
- The plastic back cover comes off to reveal the battery, motherboard, and display hiding on the other side.
- We can also see smaller components, including a speaker and a camera.

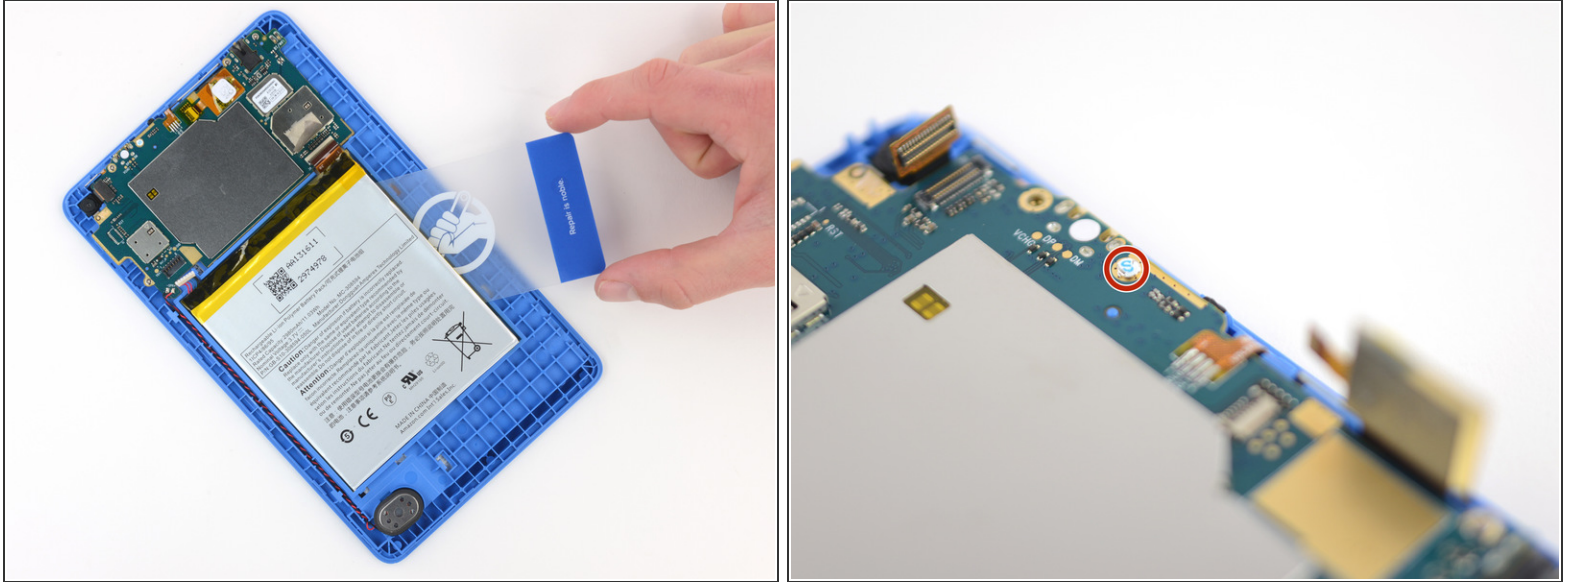
Step 3

- This battery isn't super easy to remove. It's held in with several adhesive strips that require force to separate.
- We use a card to fight the adhesive and we can pry the battery out with a bit of effort.
- At the top of the motherboard there's a little tamper evident sticker.

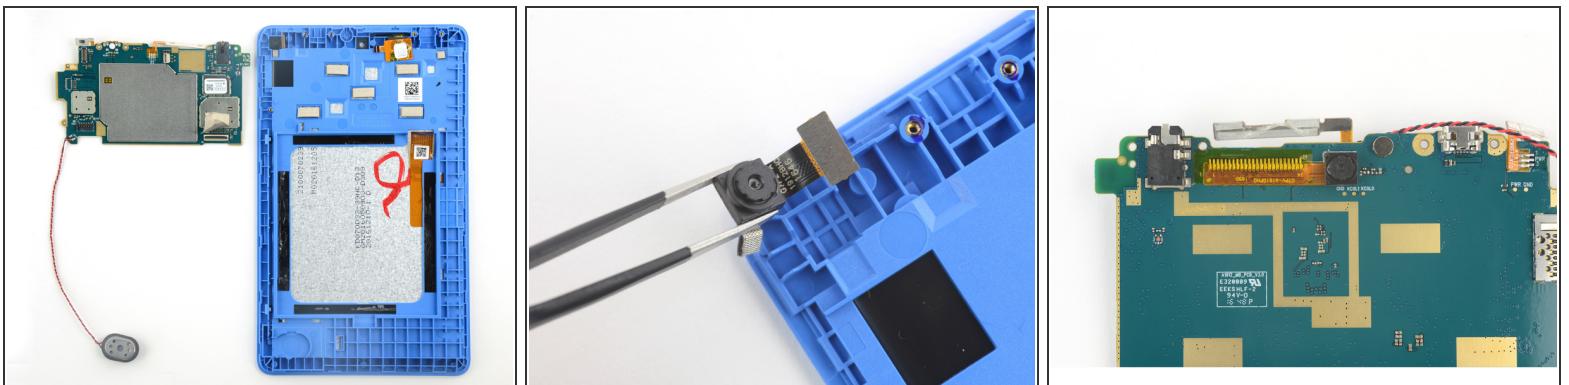
Step 4

- We can remove the motherboard after removing five Phillips screws, and disconnecting two ZIF and two press connectors.
- Front-facing camera is modular and easily pops out.
- Rear-facing camera is soldered to the board and not going anywhere.

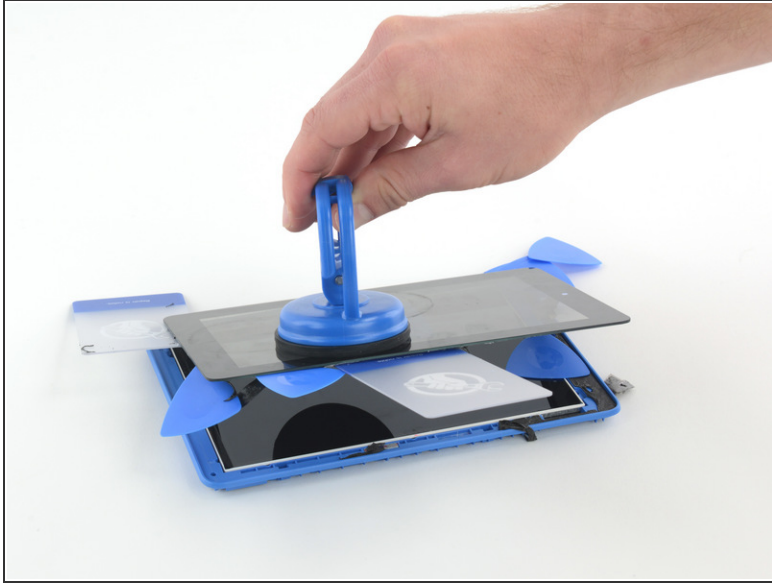
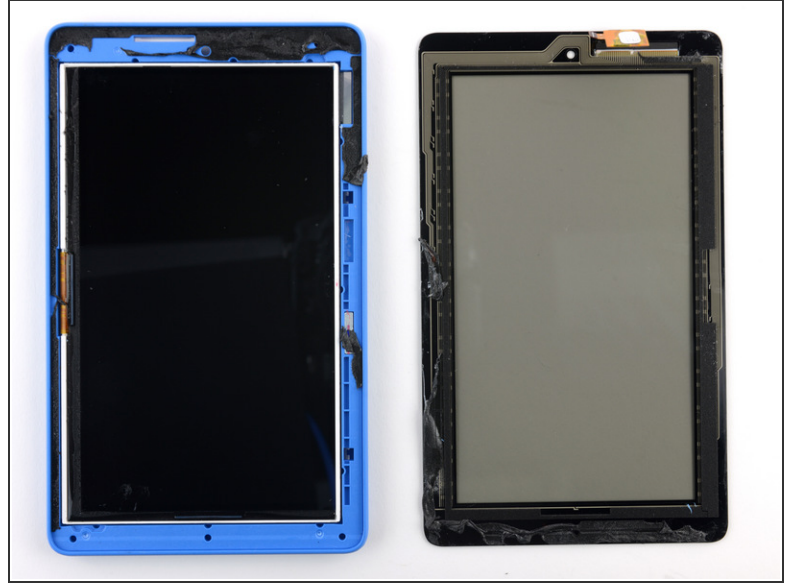
Step 5

- Just the display assembly's left. How hard is a digitizer replacement?

ⓘ Hard.

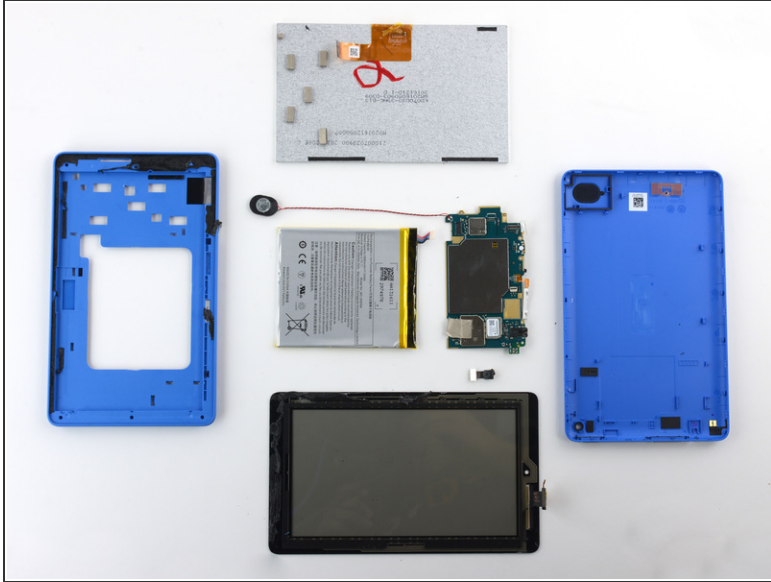
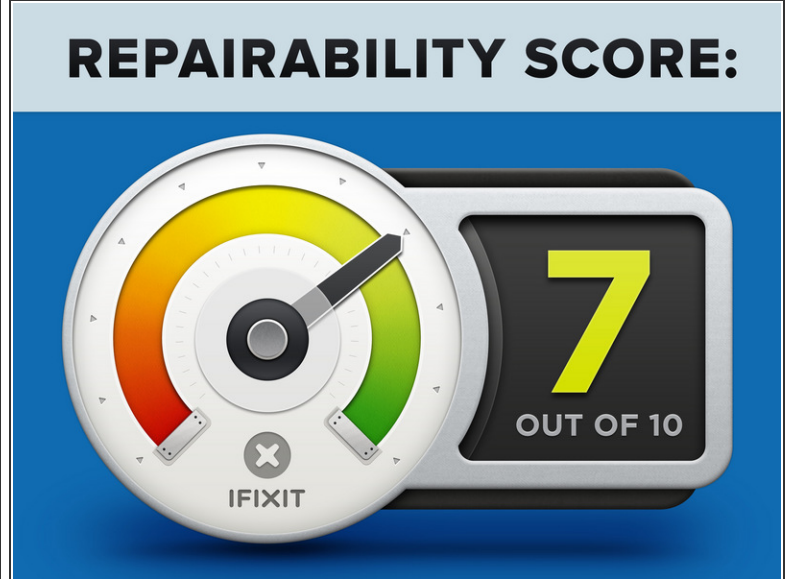
Step 6

- The Amazon Fire Tablet earns a **7 out of 10** on our repairability scale (10 is the easiest to repair):
 - The plastic case assembly is held together by clips and no adhesive, and opening only requires prying with an iFixit opening tool.
 - The digitizer and LCD panel are not fused together.
 - All of the screws in the device are Phillips screws.
 - The battery is modular, but it is held in place by somewhat stubborn adhesive.
 - Removing the digitizer and LCD panel requires fighting through some very resilient adhesive.
 - Manufacturer does not provide user-accessible repair documentation.
